# **INDOOR AIR QUALITY ASSESSMENT**

**Williams Middle School  
200 South Street  
Bridgewater, Massachusetts**

Prepared by:  
Massachusetts Department of Public Health  
Bureau of Environmental Health Assessment  
August 2002

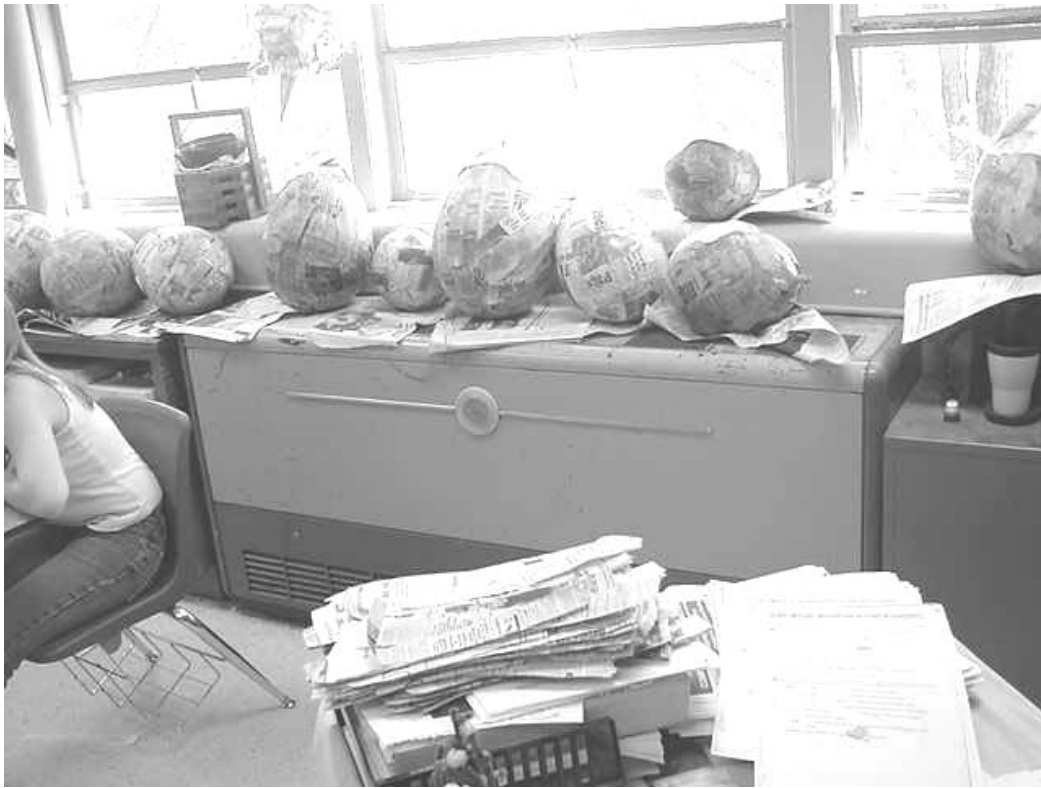
**Picture 1**

fresh air diffuser located in the top of the unit. Univents have a manual control switch with settings of off, low, medium and high. Univents were found deactivated in classrooms throughout the school. Obstructions to airflow, such as papers and books stored on univents and bookcases, carts and desks in front of univent returns, were seen in a number of classrooms (see Picture 1). In order for univents to provide fresh air as designed, intakes must remain free of obstructions and importantly, these units must remain activated and allowed to operate while these rooms are occupied.

**Univent Air Diffuser Obstructed with Drying Art Projects**

5. Reactivate exhaust ventilation in restrooms to remove odors and moisture.
6. Remove all blockages from univents and exhaust vents to ensure adequate airflow. Consider relocating seats in front of auditorium return vent.

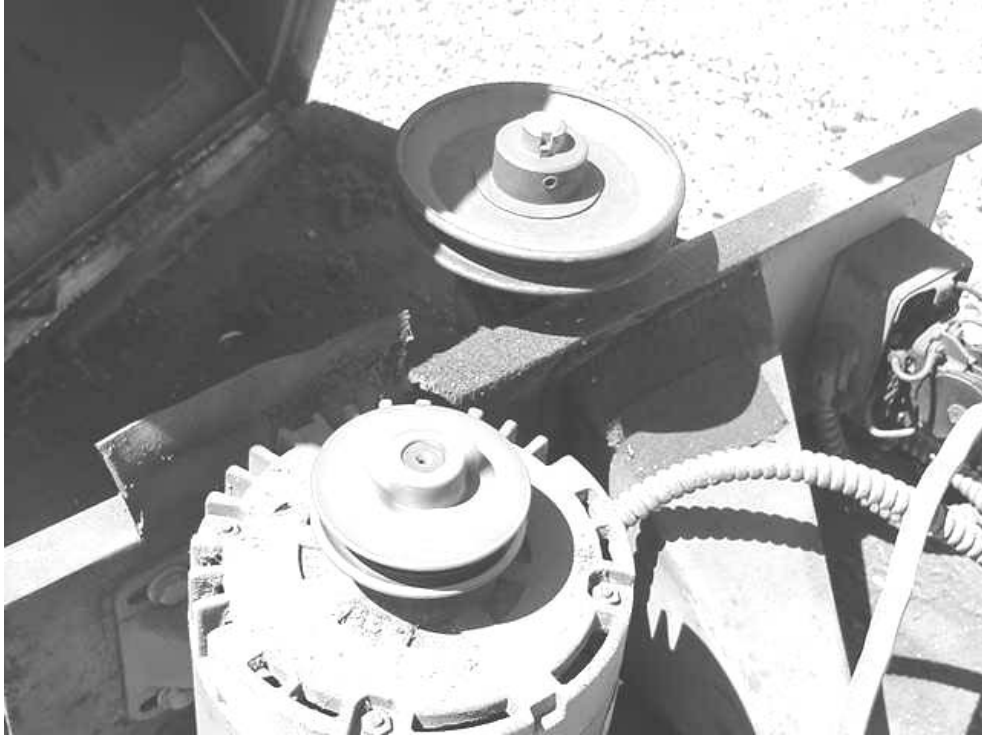
**Picture 2**

**Exhaust Motor on Roof Missing Belt**

3. Set the thermostat for modular classrooms to the fan “on” position to operate the ventilation system continuously during the school day.
4. Inspect exhaust motors and belts for proper function. Repair and replace as necessary.

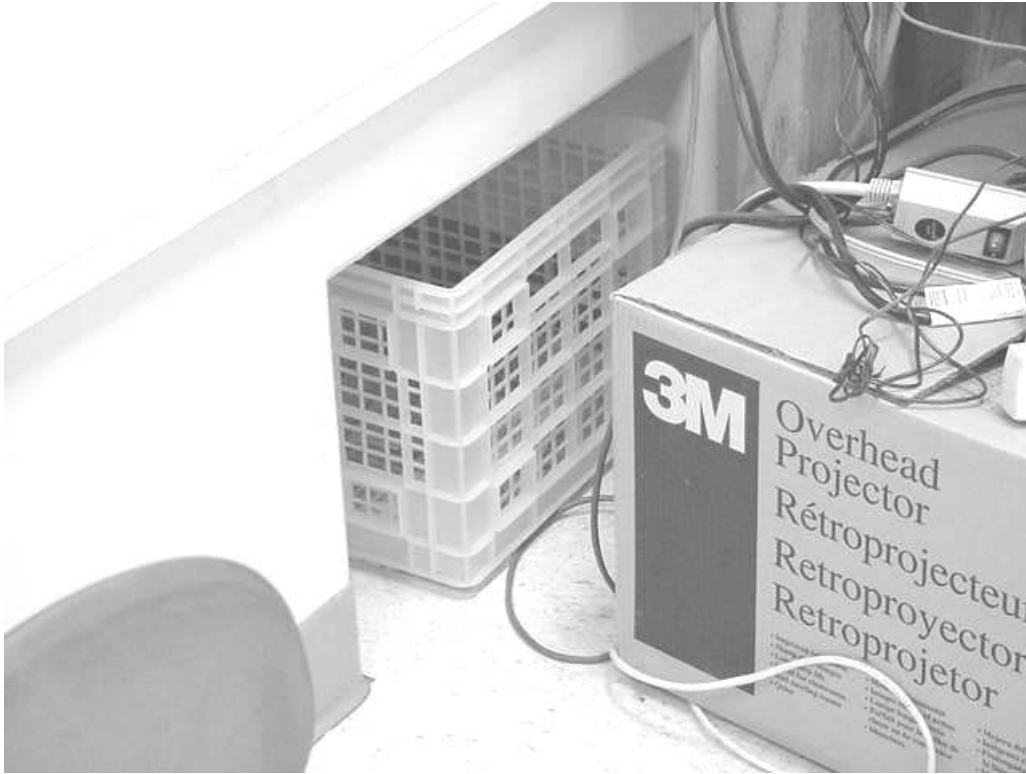
**Picture 3**

Exhaust ventilation in classrooms is provided by a mechanical system. The exhaust system in each classroom consists of ducted, grated wall vents in the white building and ungrated "cubby" holes in the red building, which create draw of air by rooftop motors. A number of exhaust vents in the red building were not operating or operating weakly, indicating that motors were deactivated or non-functional. BEHA staff examined exhaust motors on the roof and found several exhaust motors without belts or in the process of being repaired (see Picture 2). In addition, a number of the vents in both buildings were blocked by desks, bookcases, shelving and, in the auditorium, a row of seats (see Pictures 3 -6). As with the univents, in order to function properly, exhaust vents must be activated and remain free of obstructions.

**Items in and around Exhaust Cubby Obstructing Airflow**

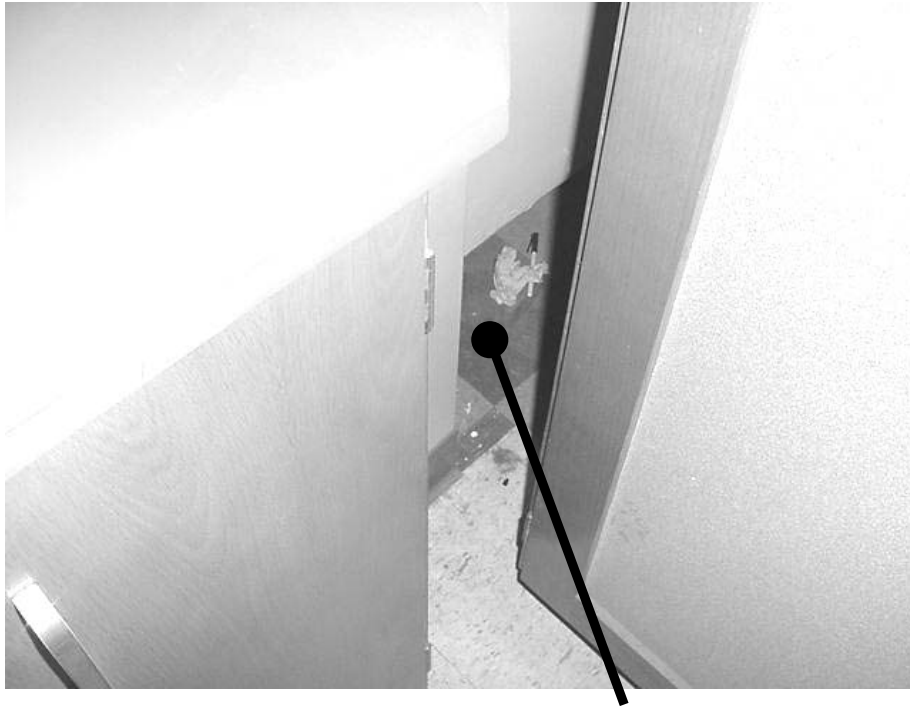
**Picture 4**

**Shelves in Science Classroom Built around Exhaust Cubby Obstructing Airflow**

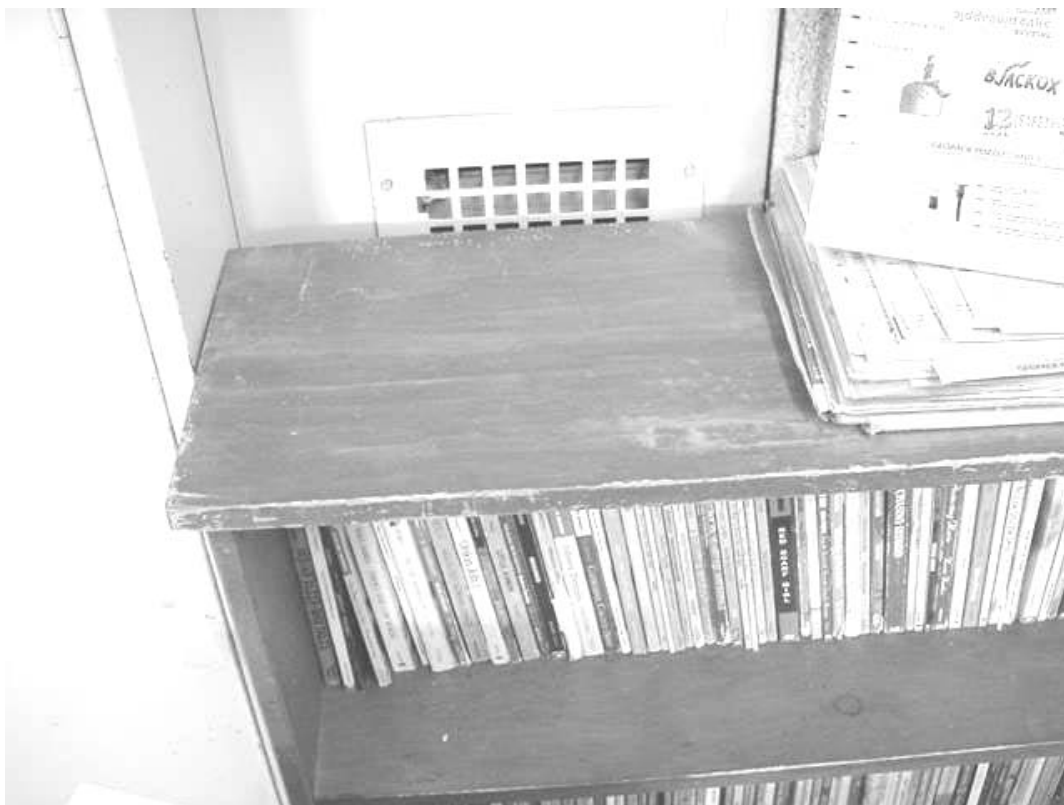
**Picture 5**

**Classroom Exhaust Vent Blocked by Bookcase**

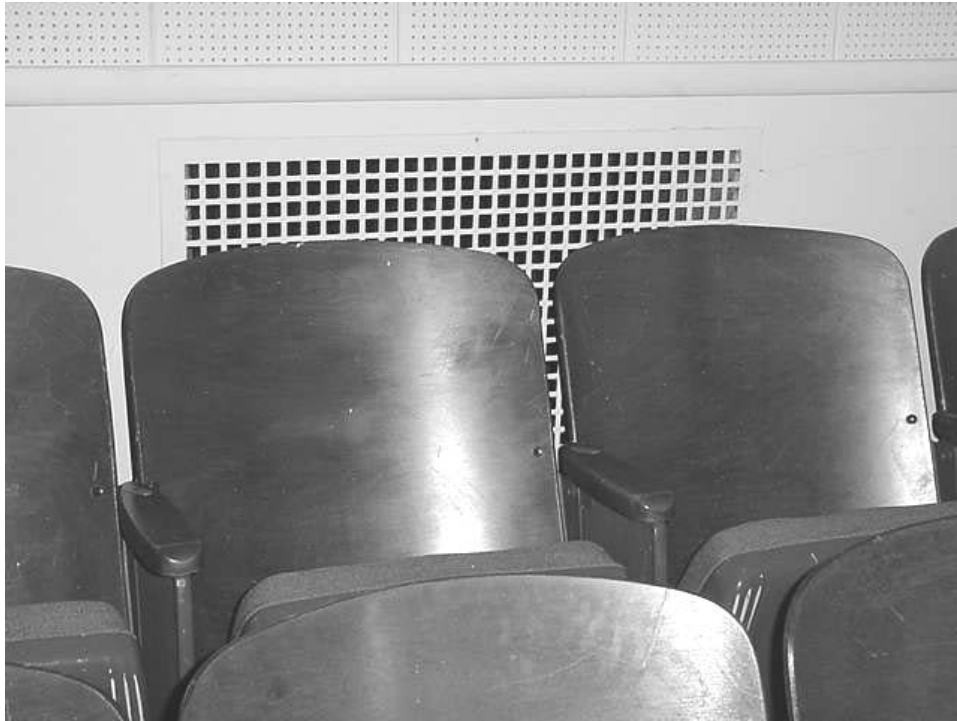
**Picture 6**

**Return Vent in Auditorium Obstructed by Row of Seats**

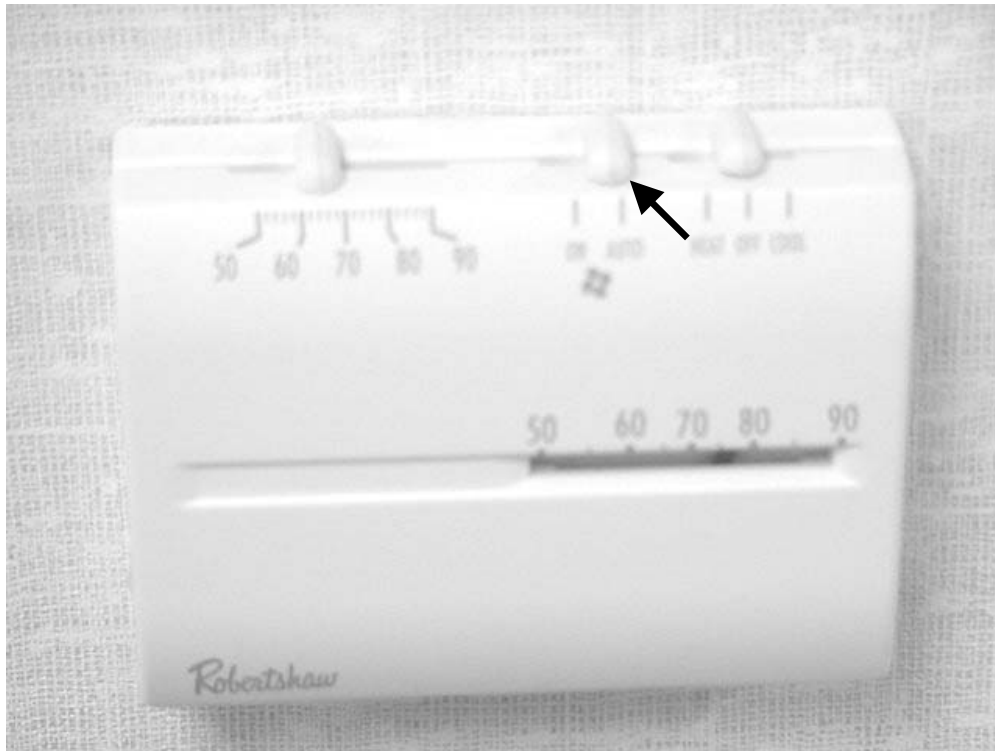
**Picture 7**

Thermostats control each heating, ventilating and air conditioning (HVAC) system (see Picture 7). These thermostats have fan settings of “on” and “automatic”. Thermostats were set to the “automatic” setting in two of the four modular rooms surveyed during the assessment. The automatic setting on the thermostat activates the HVAC system at a preset temperature. Once a preset temperature is measured by the thermostat, the HVAC system is deactivated. Therefore no mechanical ventilation is provided until the thermostat re-activates the system.

**Modular Classroom Thermostat Fan on “Auto” Setting**

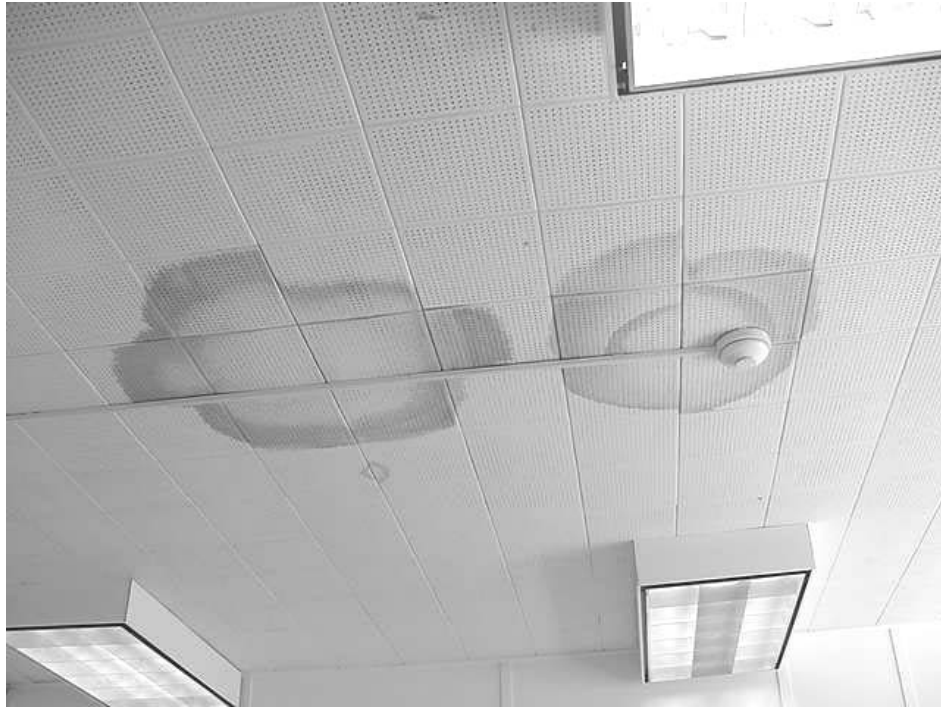
**Picture 8**

The building has a history of roof leaks. A number of classrooms have water-damaged ceiling tiles and plaster, which can indicate leaks from the roof or plumbing system (see Picture 8). Active roof leaks were reported in a number of areas including rooms 200C, 203 (consumer science), 209, 327 and in the stairwell outside of room 300 where a trash barrel is stationed to catch dripping rainwater (see Picture 9). Water-damaged ceiling tiles can provide a source of mold and should be replaced after a water leak is discovered.

**Water Damaged Ceiling Tiles, Note Tiles are of an Interlocking Design**

11. Replace any remaining water-stained ceiling tiles and wall plaster. Examine the area above and around these areas for mold growth. Disinfect areas of water leaks with an appropriate antimicrobial.

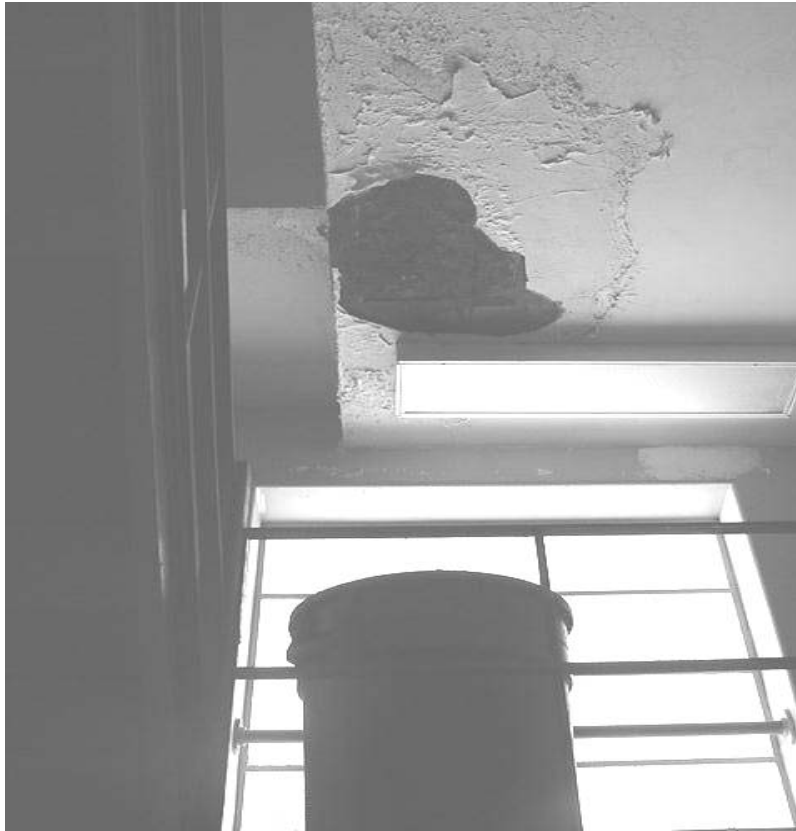
**Picture 9**

**Active Roof Leak in Stairwell outside Classroom 300, Note Water Damage Ceiling  
and Trash Barrel to Catch Rainwater**

1. Continue with plans for roof replacement. Once roof is repaired, replace any remaining water-stained ceiling tiles and other water damaged building materials. Examine the area above and around these areas for microbial growth. Disinfect areas of water leaks with an appropriate antimicrobial.

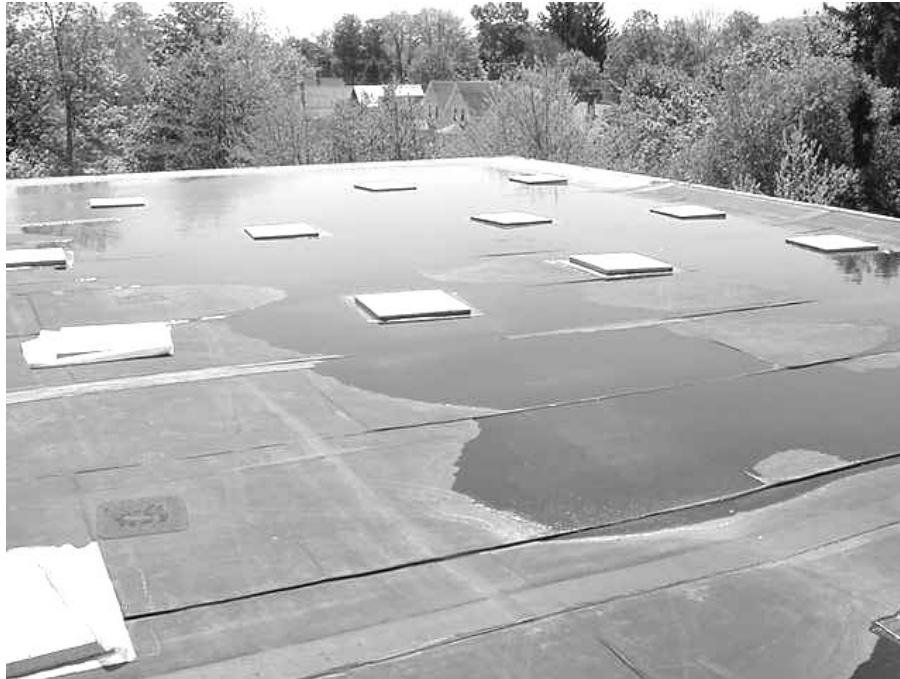
**Picture 10**

Pooling water was observed in a number of areas on the roof (see Picture 10). The freezing and thawing of water during winter months can lead to roof leaks and subsequent water penetration into the interior of the building. Pooling water can also become stagnant, which can lead to unpleasant odors and microbial growth. In addition, stagnant pools of water can serve as a breeding ground for mosquitoes. The rubber membrane of the white building is loose and rippled due to damaged insulation beneath the membrane. School maintenance personnel have placed concrete blocks in numerous areas in order to keep the loose membrane from separating from the roof substrate (see Picture 10). School officials reported that funds have been allocated for replacement of the roof; the project was reportedly out to bid at the time of the assessment.

**Standing Water and Concrete Blocks on White Building Roof**

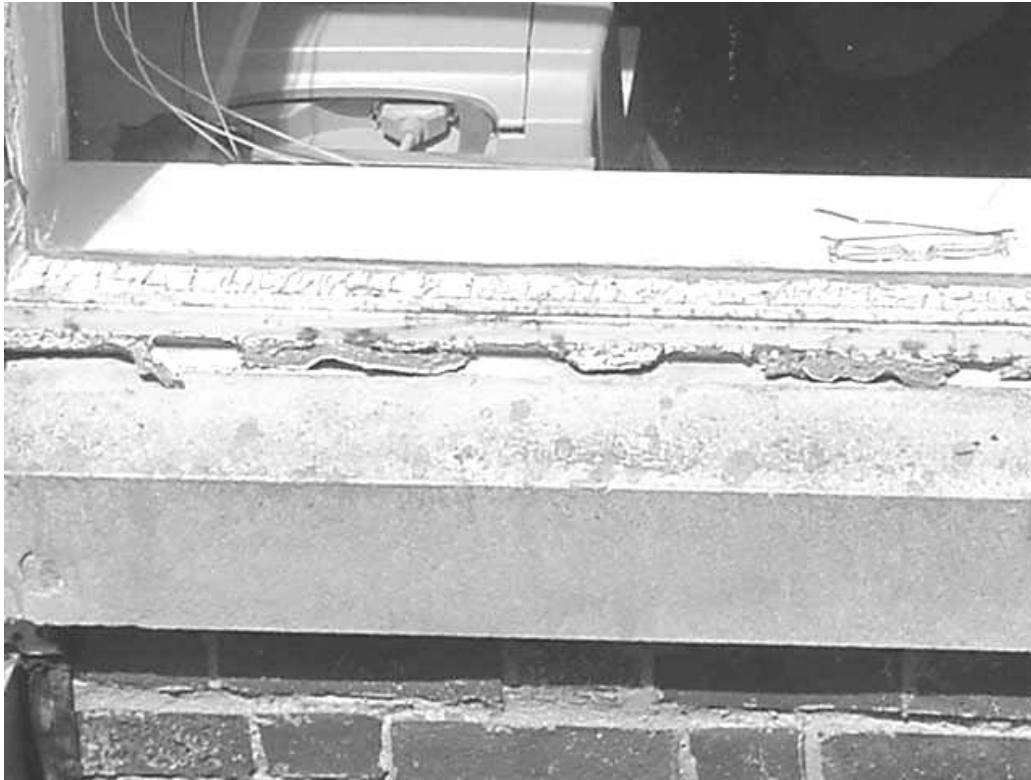
**Picture 11**

Exterior caulking around windows and frames was crumbling/damaged in a number of areas indicating that the water seal is no longer intact (see Pictures 11-13).

**Missing/Damaged Window Caulking**

7. Repair/replace loose/broken windowpanes and missing or damaged window caulking building-wide to prevent water penetration through window frames. During this project it is recommended that all water-damaged materials be examined for microbial growth and structural integrity. Repair water damaged ceilings, walls and wall-plaster as necessary.

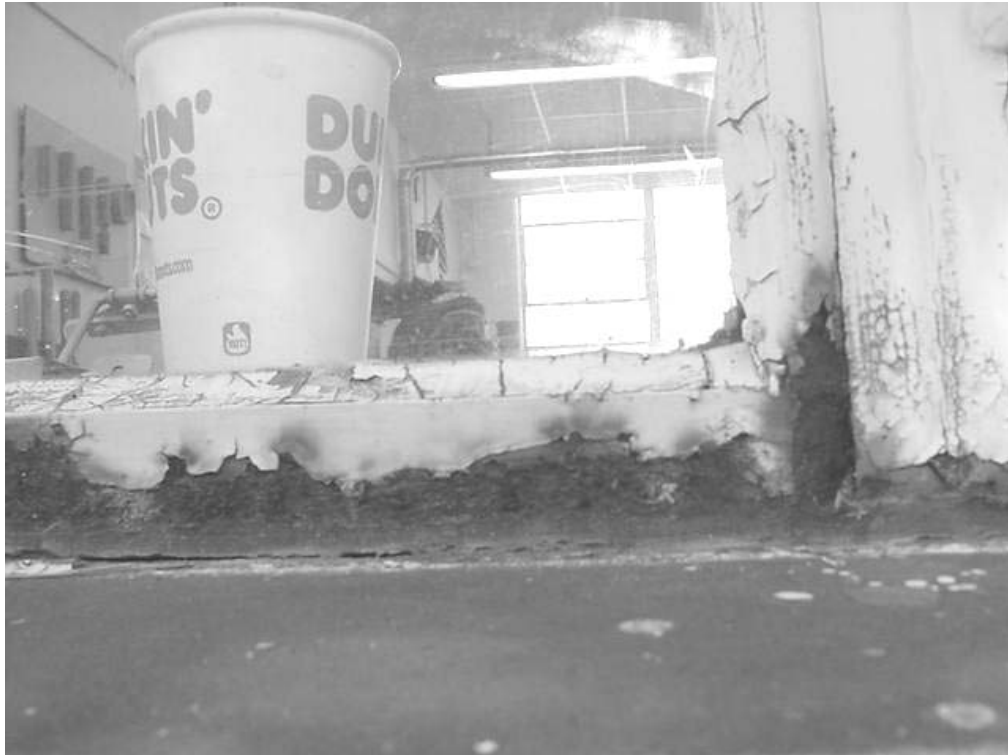
**Picture 12**

**Rusted Metal/Water Damaged Window Frame**

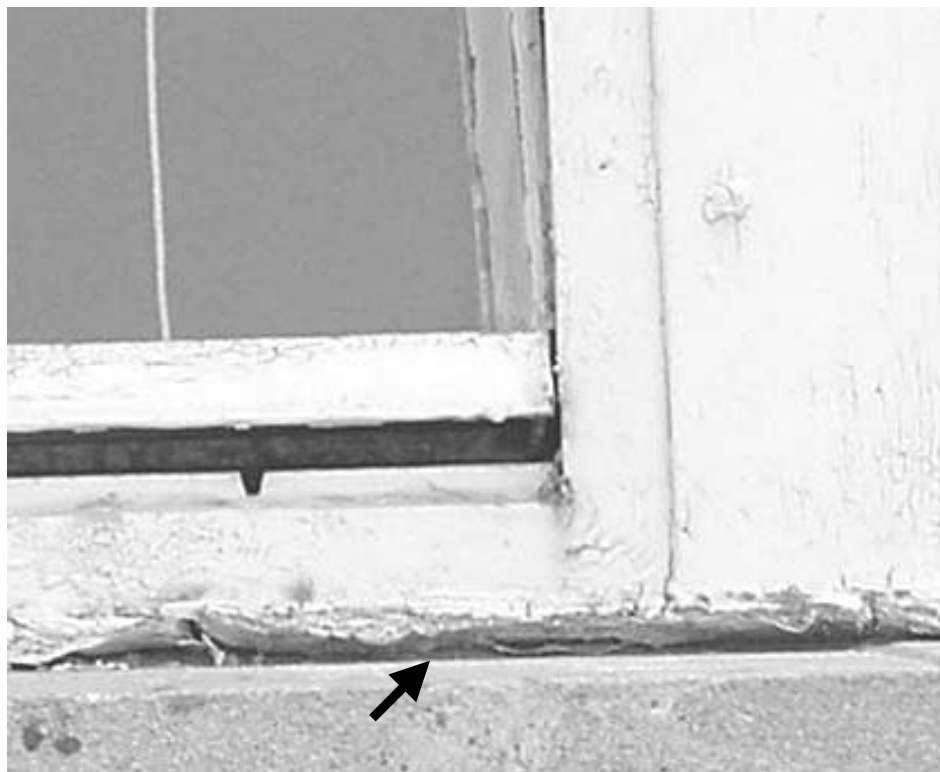
**Picture 13**

**Caulking Peeling away from Window Frame**

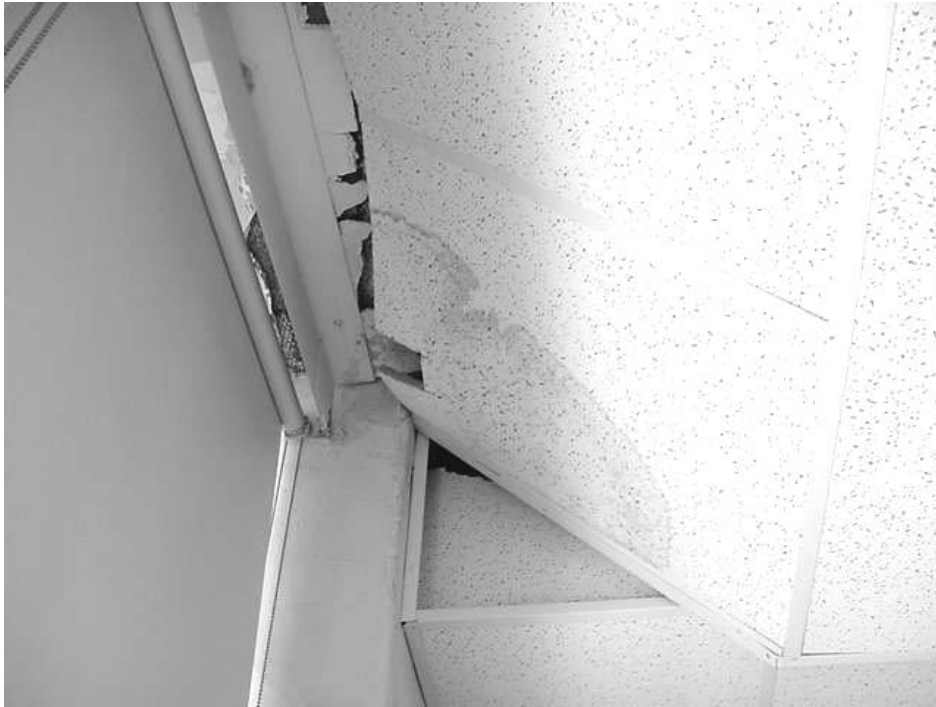
**Picture 14**

Broken windows were observed in several areas (see Tables) as well as water damaged plaster and other building materials around windows (see Pictures 14-18). The damage is most likely attributable to water penetration around window frames during rainstorms, which can lead to subsequent mold growth under certain conditions. Replacement of caulking and repairs of window leaks are necessary to prevent water penetration. Repeated water damage can result in mold colonization of window frames, curtains and items stored on or around windowsills.

**Water Damaged Ceiling Tiles near Top of Window Frame in Room 203**

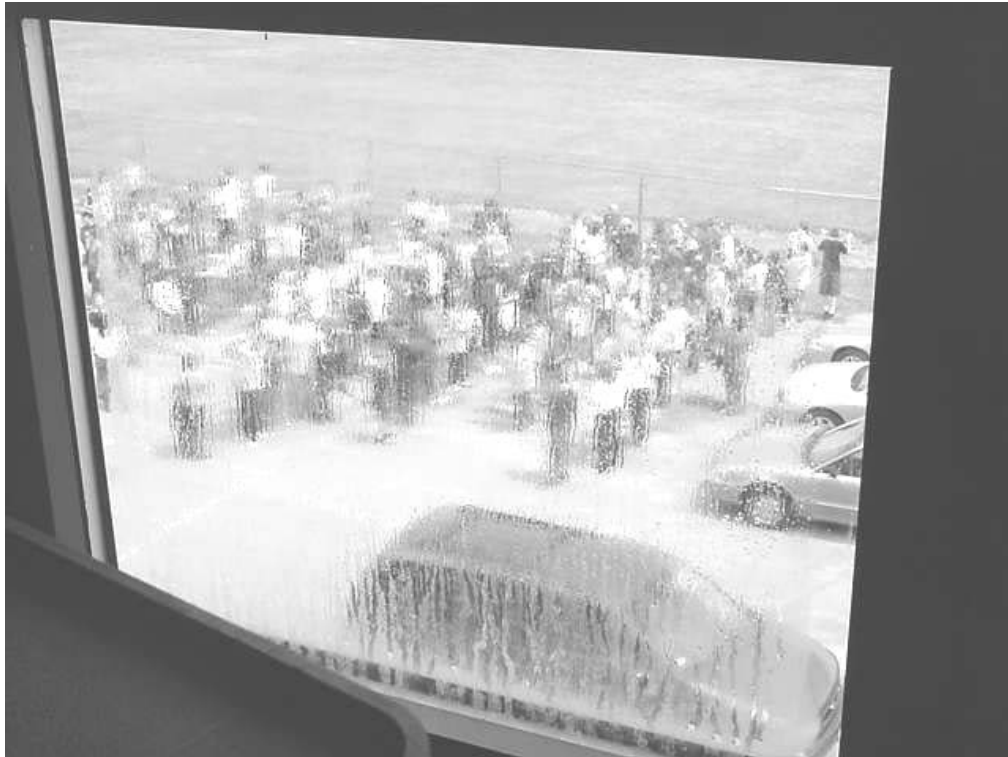
**Picture 15**

**Condensation between Classroom Window Panes**

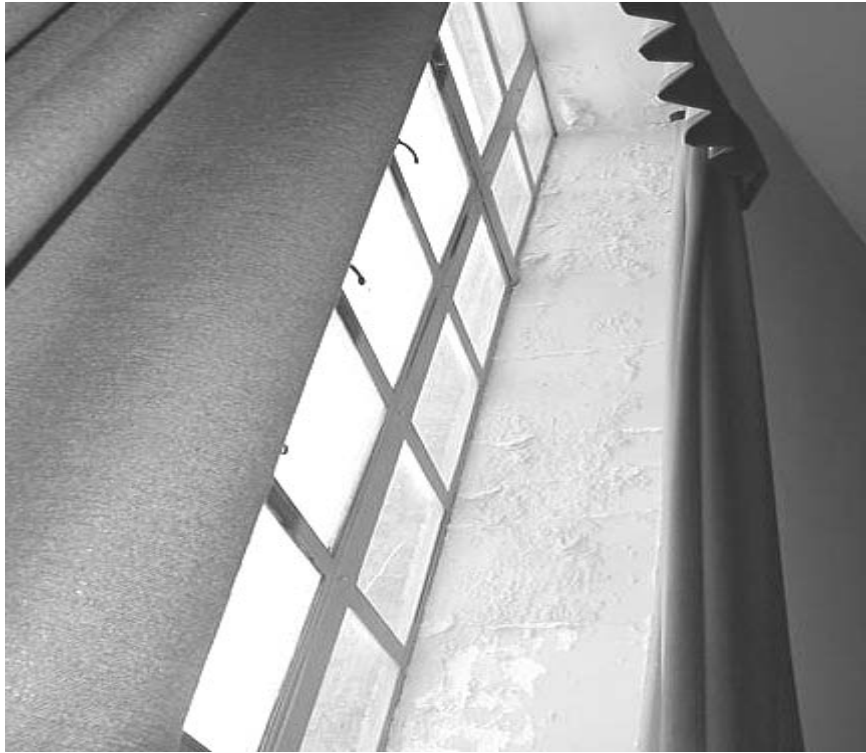
**Picture 16**

**Water Damaged Plaster around Window Frame in Auditorium**

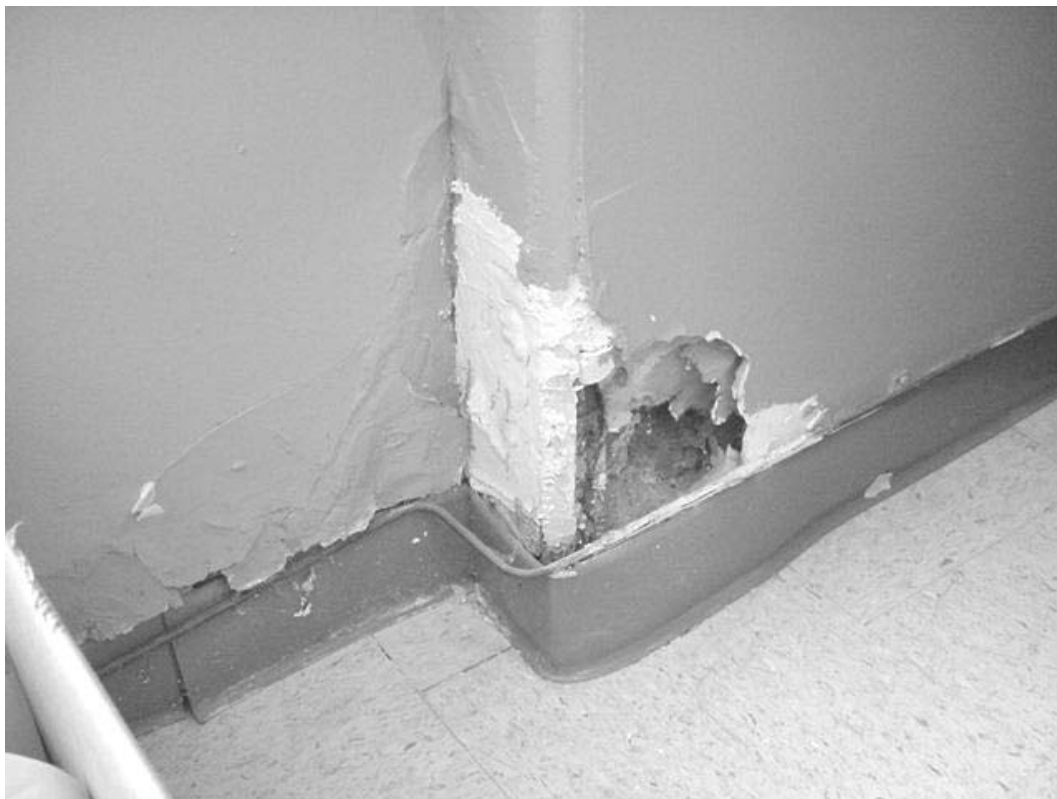
**Picture 17**

**Water Damaged Wall Plaster in Classroom 307**

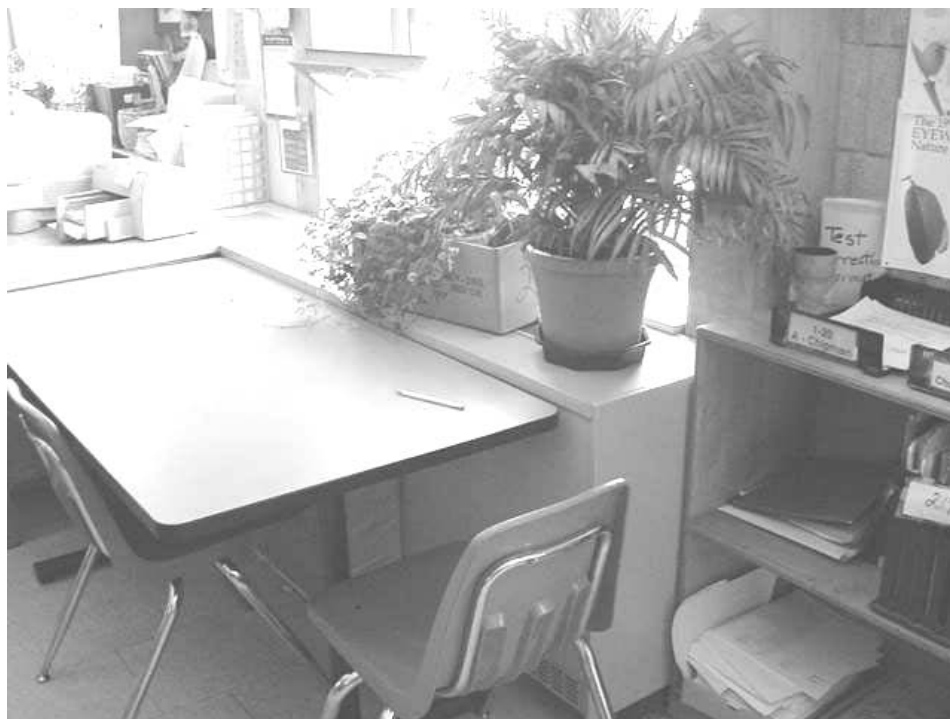
**Picture 18**

Several classrooms contained a number of plants. Plant soil and drip pans can serve as a source of mold growth. Plants and potting soil were found on top of univents in several classrooms. Several plants were noted in standing water. Plants should be located away from the air stream of univents to prevent aerosolization of dirt, pollen or mold.

**Plants on top of Univent Air Diffuser in Classroom**

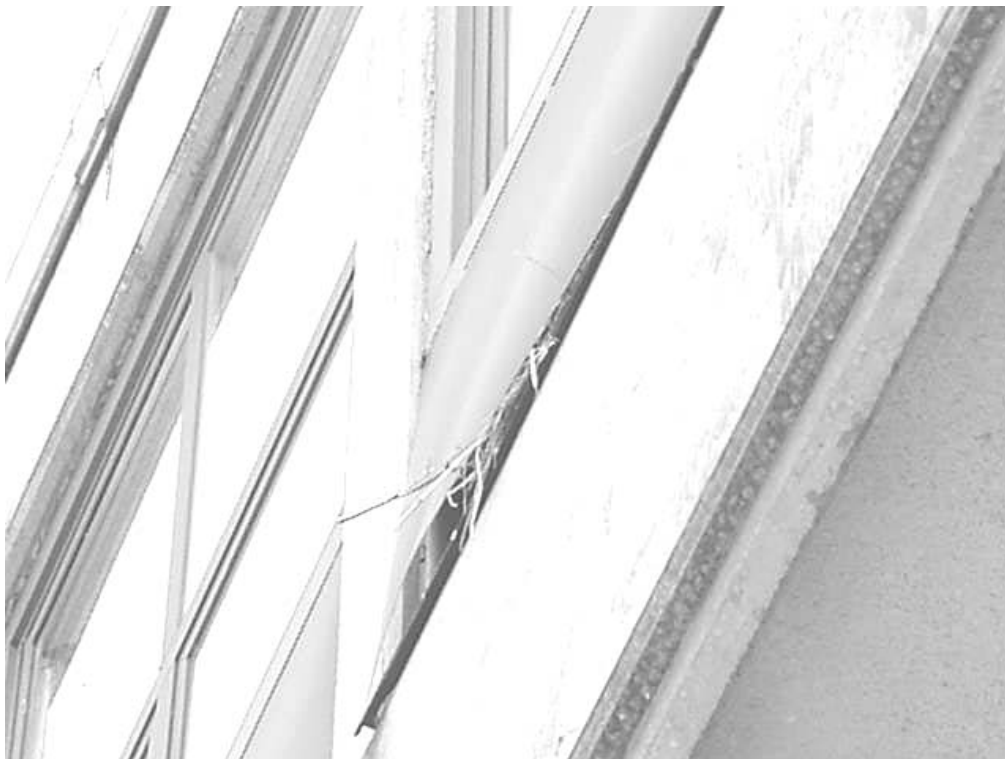
**Picture 19**

Signs of bird roosting and nesting materials were observed in a number of recesses (e.g. overhangs, broken block windows) around the exterior of the building (see Pictures 19 & 20). Birds can be a source of disease, and bird wastes and feathers can contain mold and mildew, which can be irritating to the respiratory system. No obvious signs of bird roosting inside the building or in ventilation components were noted by BEHA staff or reported by occupants.

**Nesting Material beneath Exterior Wall Panel**

9. Remove bird's nests from exterior of building and install/repair bird screens as needed. To prevent possible exposure to bird wastes, implement the corrective actions recommended concerning remediation of bird wastes in Appendix II of this report. To prevent possible spread of bird waste particulates to occupied areas employ the methods listed in the SMACNA guidelines for Containment of Renovation in Occupied Buildings (SMACNA, 1995).

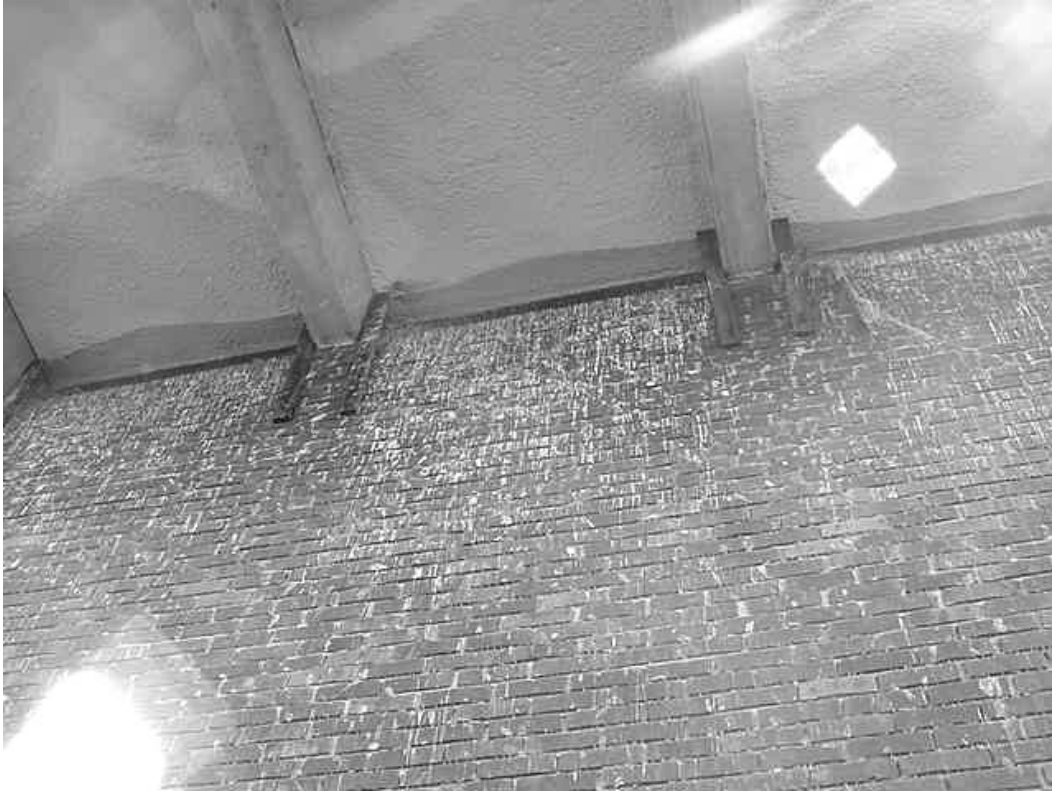
**Picture 20**

**Gymnasium Awning White Material Indicates Accumulated Bird Wastes**

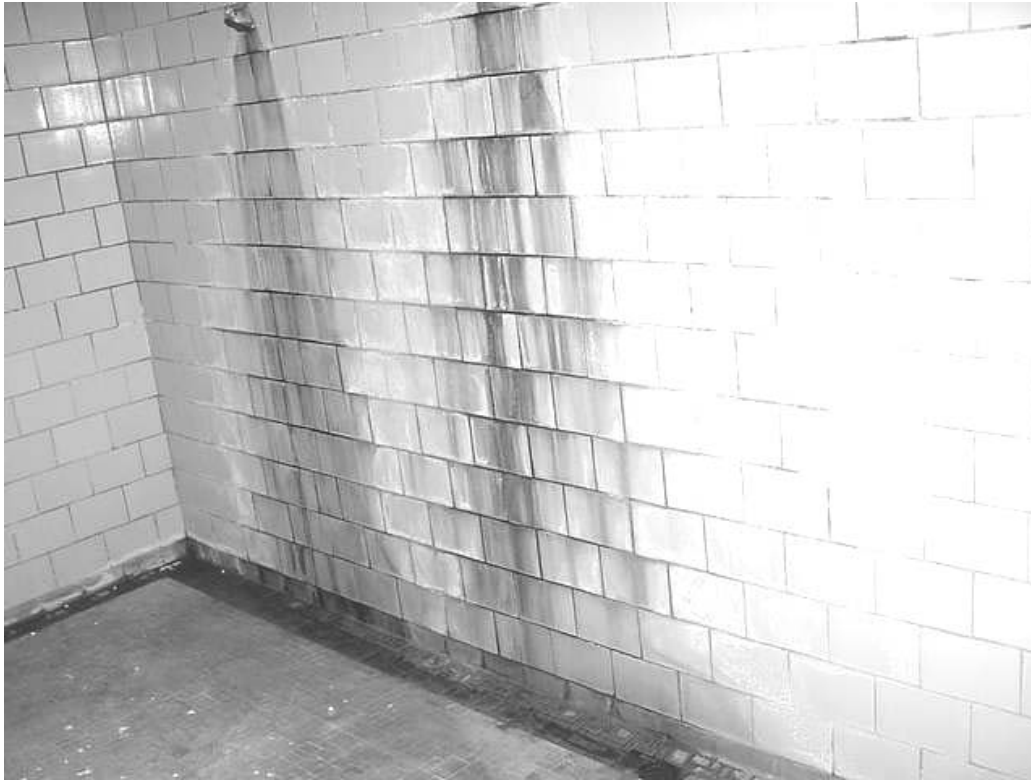
**Picture 21**

Active mold growth was observed on tiled walls in the shower area of the boy's locker room. The locker room showers were reportedly deactivated and the area is being used for storage. The characteristic pattern on walls and troughs directly below indicate that the deactivated showerheads are leaking (see Picture 21).

**Mold Growth in Boy's Locker Room Shower Area**

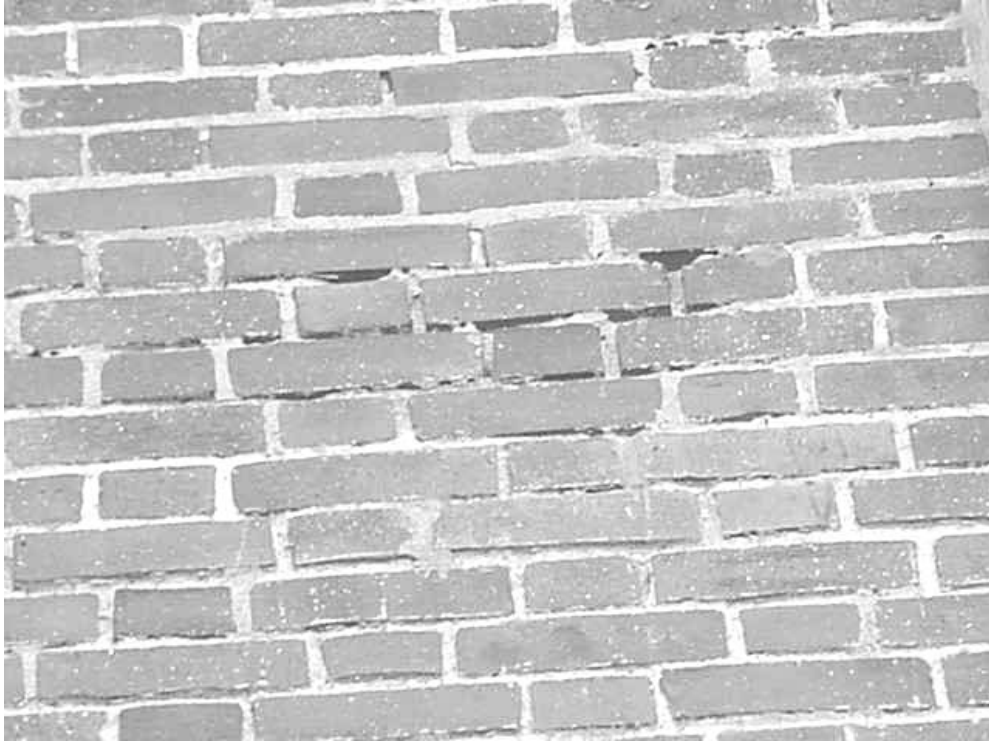
**Picture 22**

The exterior walls had spaces/cracks in brickwork. In many areas mortar around exterior brickwork appears to be crumbling or missing (see Picture 22). These conditions are breaches of the building envelope and provide a means for water entry into the building. Repeated water penetration can result in the chronic wetting of building materials and the potential for microbial growth. In addition large wall cracks may provide a means of egress for pests/rodents into the building.

**Missing/Damaged Mortar around Exterior Brick**

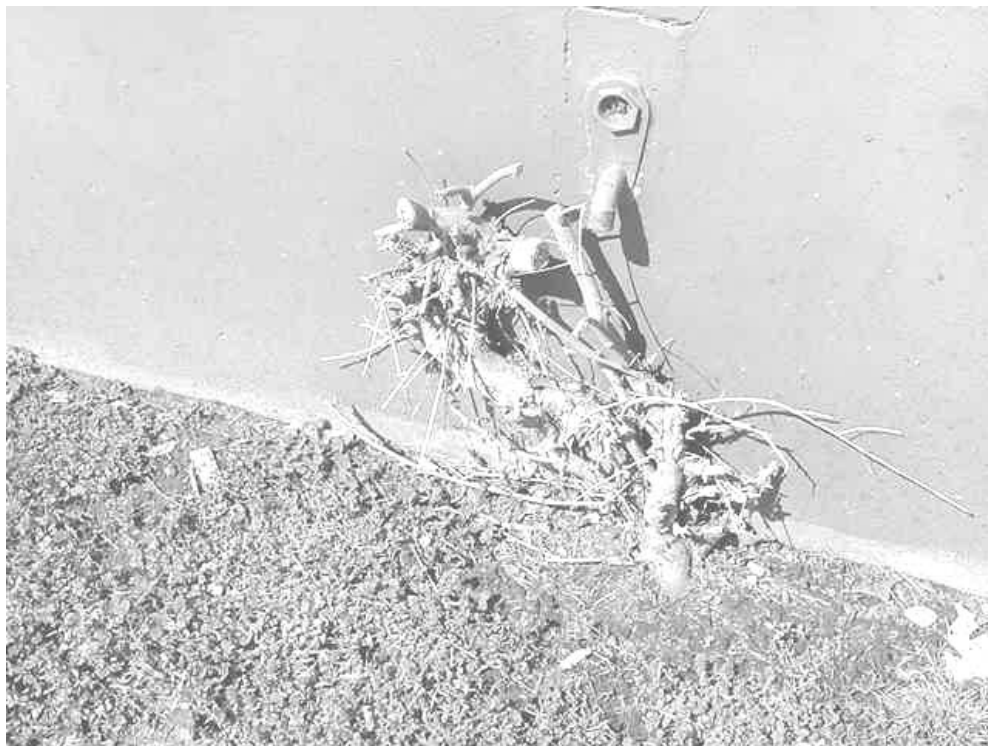
**Picture 23**

Small trees and other plants were also seen growing in the tarmac/exterior wall junction (see Picture 23). The growth of roots against the exterior of foundation walls, as well as spaces between the tarmac, can bring moisture in contact with brick and

foundation structures, which may eventually lead to moisture penetration below ground level areas of the building.

**Plant Growth against Building/Foundation**

15. Remove plant growths against the exterior wall/foundation of the building to prevent water penetration. Trim trees in rear of building away from brickwork.

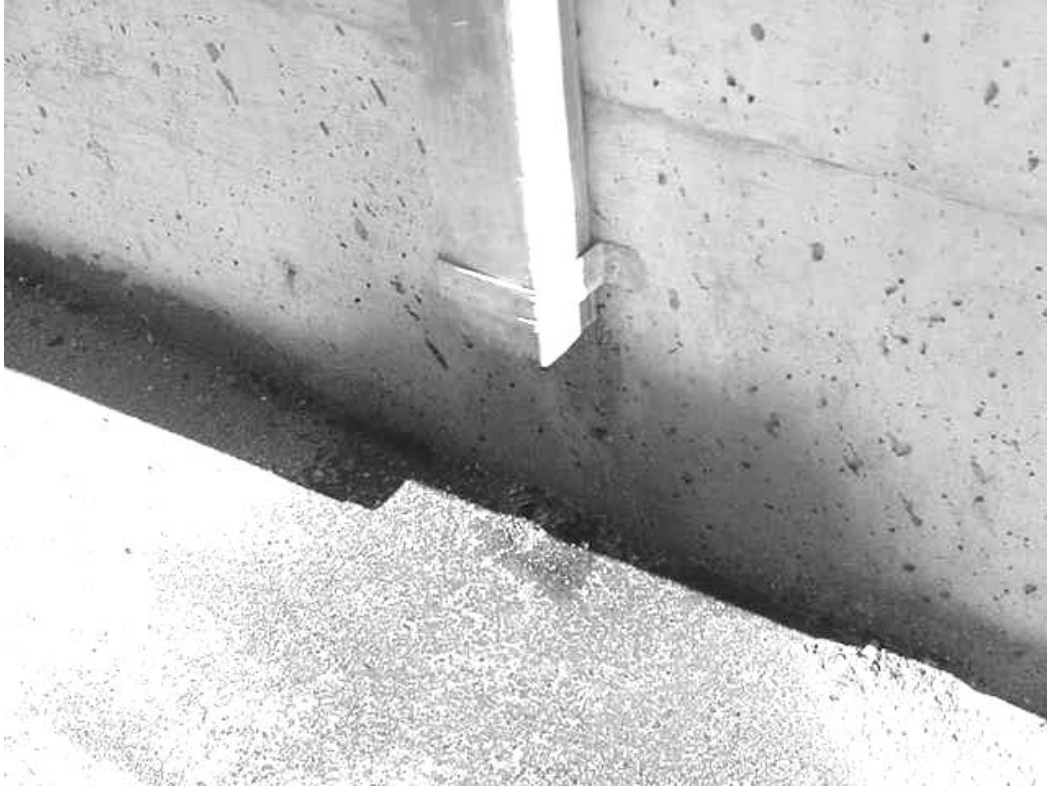
**Picture 24**

The exterior walls of the modular units appeared to be intact and drainage adequate. A gutter/downspout system exists for the units; however one of the downspouts was missing an elbow (see Picture 24), which can allow rainwater to pool on the ground at the base of the building or against exterior walls. The freezing and thawing action of water during winter months can create cracks and fissures in the foundation. Over time, this process can undermine the integrity of the building envelope and provide a means of water entry into the building through capillary action through foundation

**Missing Downspout Elbow Extension, Note Staining of Foundation**

- growth, repair/replace as necessary. Disinfect areas of microbial growth with an appropriate antimicrobial as needed.
14. Replace/repair damaged downspouts and install elbows in a manner to direct rainwater away from the building.

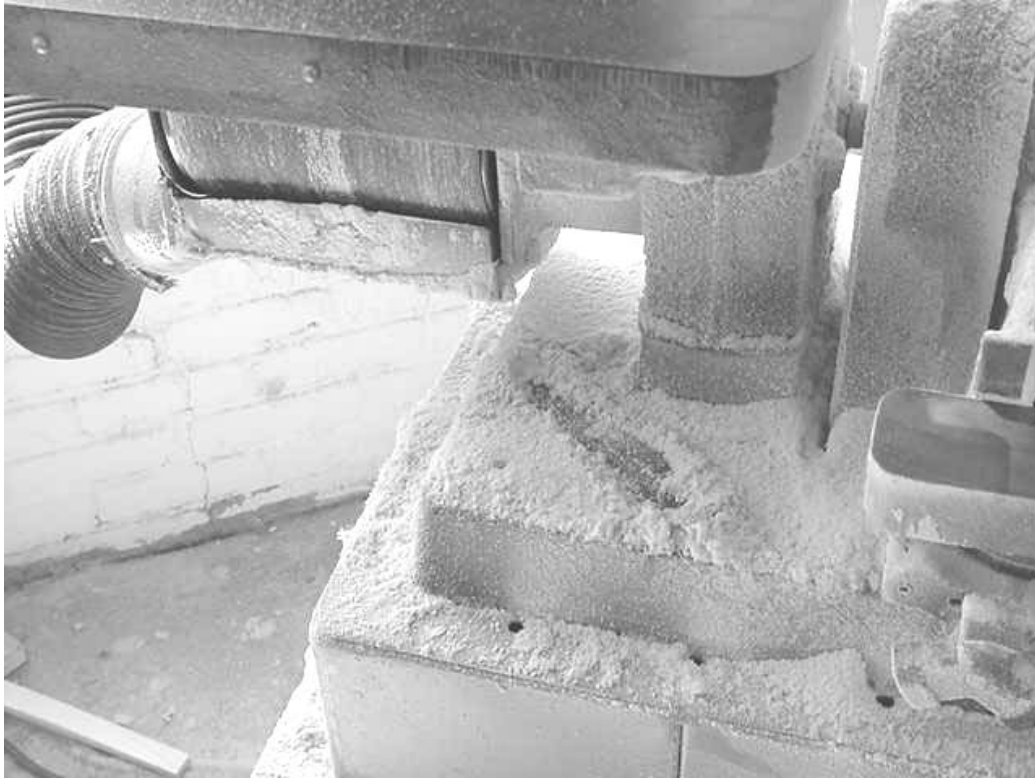
**Picture 25**

Several other conditions that can potentially affect indoor air quality were identified. Excessive amounts of wood dust on flat surfaces was noted in the woodshop (see Picture 25). BEHA staff also noted a significant amount of wood dust in the wood shop general return vent, which indicates that sawdust is aerosolized from machinery and is entrained (drawn into) by the ventilation system. The wood shop contains a dedicated AHU. Wood dust can be irritating to the eyes, nose, throat and respiratory system. Within the AHU are heating elements. Under certain conditions, wood dust is a fire hazard.

**Accumulated Wood Dust in Woodshop, Note Machine is Connected to Dust Collector**

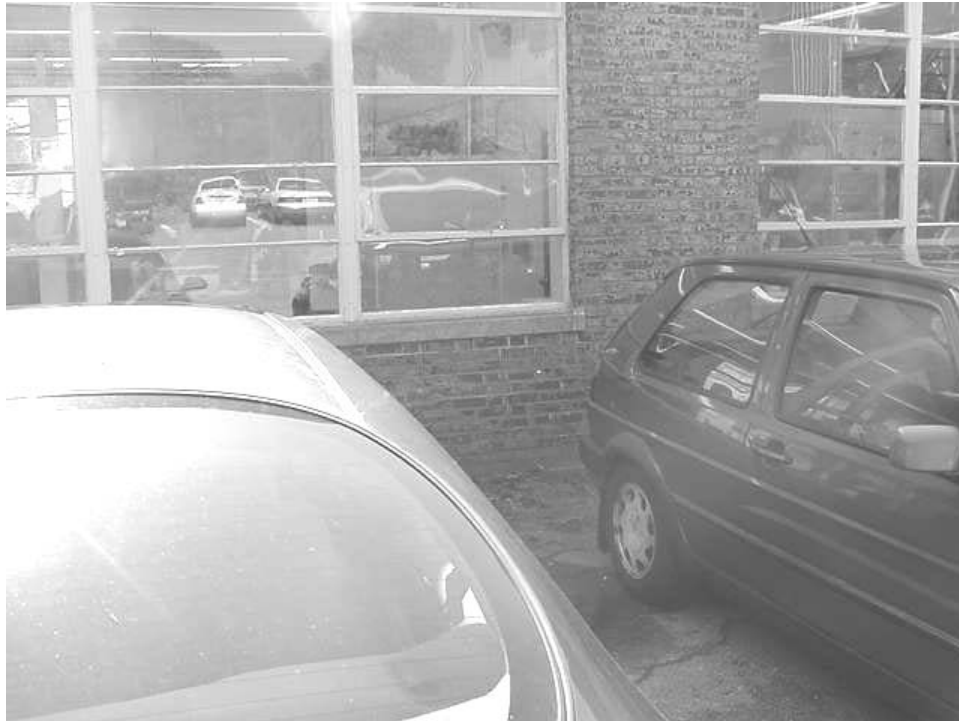
**Picture 26**

Cars parked in close proximity of the school (see Picture 26) can cause vehicle exhaust to be entrained by the mechanical ventilation system and open windows under

certain weather conditions, which may, in turn, provide opportunities for exposure to combustion products such as carbon monoxide.

**Cars Backed Up Against Building (Outside Woodshop/Art Room)**
